PowerPatch™ 25KV Transformer Repair at Dominion Power

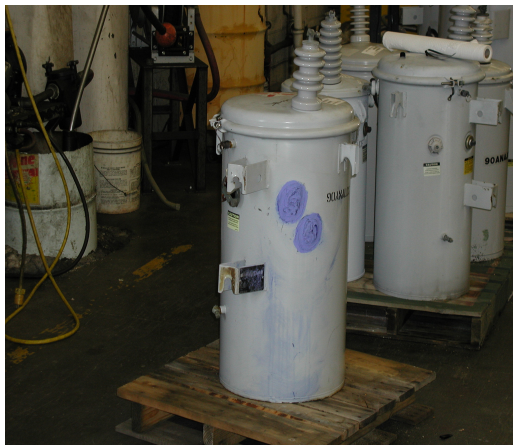
Problem: This transformer was in the shop for unknown reasons. Dominion Power drilled two 1/8-inch holes in the side to test the adhesion of [PowerPatch™](#) under “real world” circumstances. We were to apply the PowerPatch™ while the surface was exposed to the elements and to test the adhesion while oil is leaking from the side. This transformer was hung by straps from the ceiling and not resting on the floor.

Results: The PowerPatch™ cured for approximately 20 minutes and then the transformer was refilled with oil. It was pressurized to 5 lbs and a blue leak detector powder was placed on the patch. It was set outside for the weekend. This photo was taken on Monday after three days outside in the elements. At this time there are no visible leaks in either of the patches. The transformer was put back into service and was working at 100% efficiency until a hurricane destroyed it the next year.

Solution: We repaired the two holes using the normal PowerPatch™ process and product. The surface was cleaned with a [Type TR™](#) solvent wipe included in the complete PowerPatch™ kit (catalog #EP-KIT) and then sanded using a 100-grit sanding cloth. The surface was sanded to improve adhesion and remove any sort of contaminant, such as rust, salt and dirt, and then wiped again with a Type TR™ solvent wipe. During the cleaning and sanding process another worker was kneading the putty stick, which requires approximately 5-10 minutes of preparation before applying. The putty stick patch should be applied immediately after the cleaning process to prevent oil from leaking onto the outer surface. Once the putty stick patch was applied, the PowerPatch™ parts A & B were mixed together. The mixture was applied to the surface of the transformer with a horizontal force to prevent oil from seeping out and to prevent air bubbles in the solution. Finally, the sides were pressed down flat by circling the patch with a wet gloved finger.
