PowerPatch[™] Oil Filled Pipes Repair MECO Substation

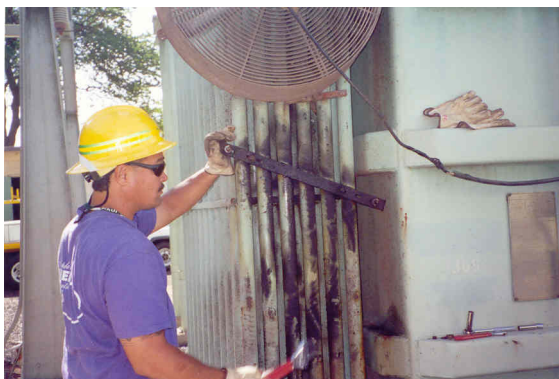
Problem: Maui Electric Company had leaking pipes on the back side of the mounting bracket for a transformer cooling fan. The bracket itself was corroded from the salty environment, and was in poor condition. The pipes behind the bracket actually had loose metal and rust flakes where the brackets touched them.

Bracket being removed to locate leak.

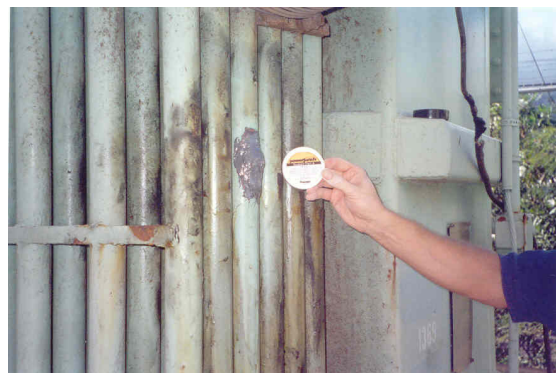
PowerPatch[™] repair of leak.

Solution: MECO decided to try [PowerPatch[™]](#) to fix the pipes without taking the substation out of service or waiting for an outage that would require replacement or repair. The pipes were prepared per PowerPatch[™] instructions. The metal was sanded to remove the paint and rust around the leak. To remove the oil, the sanded area was then wiped clean with the [Type TR[™]](#) cleaner provided in the complete PowerPatch[™] kit (catalog #EP-KIT). A small piece of the putty stick was cut, mixed, and then applied to plug the hole. Pressure was applied to the putty until it cured approximately 6 minutes later. Pressure is needed to keep the oil from flowing out of the pin-hole leak. However, the first attempt to stop the leak was unsuccessful. The procedure was repeated again and stopped the oil leak. Next, parts A & B of PowerPatch[™] were mixed together and then smoothed over the putty stick in order to make a long-term seal.

Results: The crews waited 1 hour and then remounted the bracket and fan unit. The repair was done in November of 2002 and is still intact today. MECO approved PowerPatch[™] to be used throughout their system.
