PowerPatch[®] Pad-Mounted Transformer Repair at Sierra Pacific Power

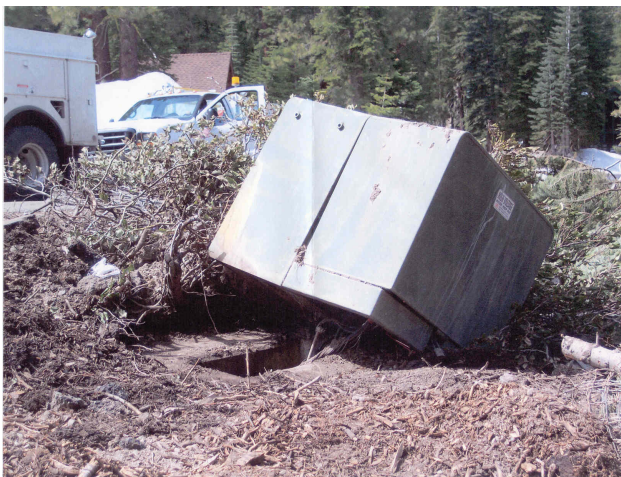
Problem: This transformer was hit by a snow plow. After the crews leveled the transformer back on the pad they discovered that the plow had caused a small hole on the corner and oil had started leaking out of it. They decided to try PowerPatch[®].

Transformer hit by snow plow.

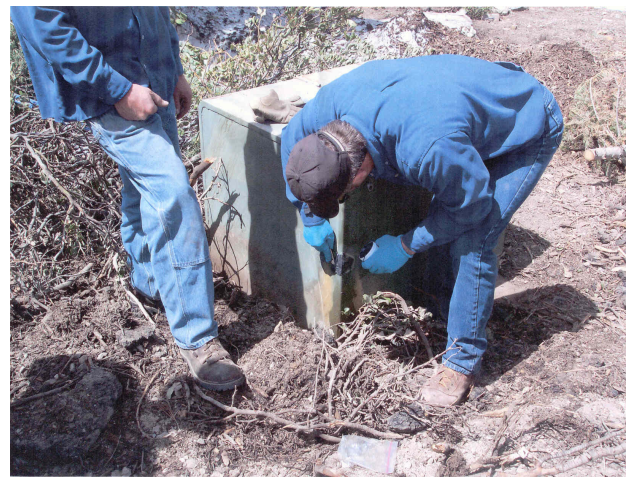
PowerPatch[®] being applied to transformer.

Solution: Sierra Pacific crews repaired the hole using the normal PowerPatch[®] process and product. The surface was cleaned with a [Type TR[™]](#) solvent wipe included in the complete PowerPatch[®] kit (catalog #EP-KIT) and then sanded using a 100-grit sanding cloth. The surface was sanded to improve adhesion and remove any sort of contaminant, such as rust, salt and dirt, and then wiped again with a Type TR[™] solvent wipe. During the cleaning and sanding process another worker was kneading the putty stick, which requires approximately 5-10 minutes of preparation before applying. The putty stick patch should be applied immediately after the cleaning process to prevent oil from leaking onto the outer surface. The crews kept pressure on the putty stick in order to plug the hole and stop the leaking. Once the putty stick patch was applied, the PowerPatch[®] parts A & B were mixed together. The mixture was applied over the putty stick surface and the transformer to lock down the putty stick, creating a permanent patch.

Results: PowerPatch[®] stopped the leak in the transformer and the crews were satisfied with the results.
