## PowerPatch<sup>®</sup> Repair of City Power Cydna Substation 22kV 40 MVA Transformer

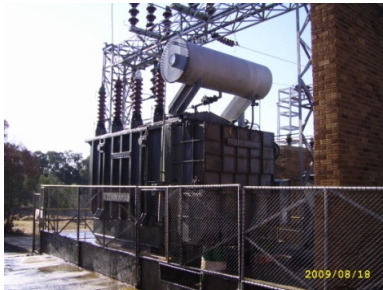
View of transformer

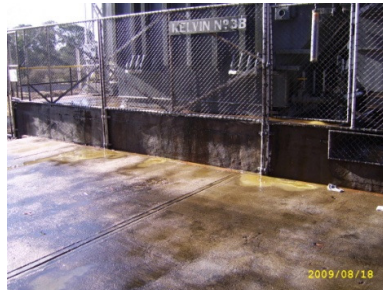
**Problem:** City Power in Johannesburg South Africa had a badly leaking 40 MVA substation transformer that was leaking oil from the lids and doors. The transformer was installed in 1932 and was leaking between 700 and 800 litres of oil a week.

Magnitude of the oil leak

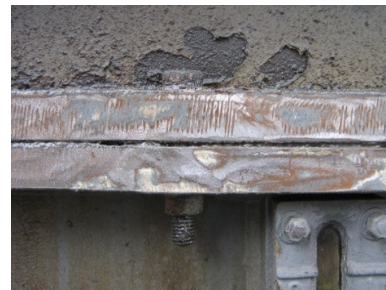
Cleaned seam

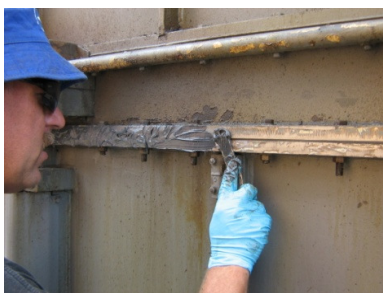
Applying slow cure PowerPatch<sup>™</sup>

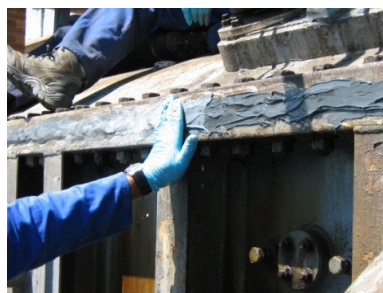
Smoothing out the PowerPatch<sup>™</sup>

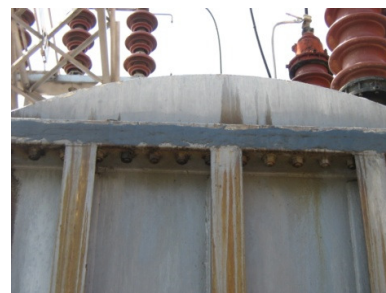
Completed job.

**Results:** After more than 1 week running at full power there has been no necessity to top up the oil. This already means a saving of 800liters of oil.
