PowerPatch™ Repair of Xcel Energy Substation Transformer

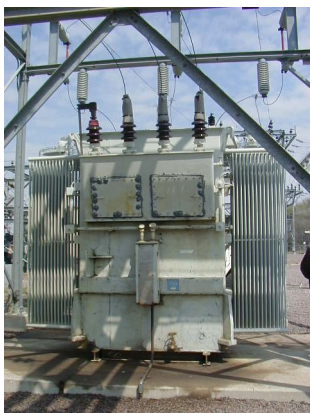
Problem: Excel Energy in Minnesota had a badly leaking substation transformer in Morton, Minnesota that was leaking oil from the doors and bolts. The transformer was over 30 years old.

View of transformer.

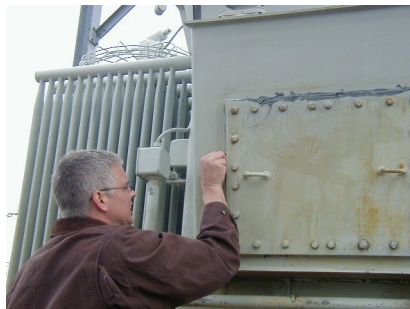
Applying the putty stick.

Solution: Xcel called us to come out and apply PowerPatch™ to the transformer to attempt a fix instead of replacement or removal from service. The bolts and doors were prepared by Xcel field crews prior to our arrival. The paint and metal were sanded to prepare the metal surface for the application of PowerPatch™. To remove the oil, the sanded area was then wiped clean with the Type TR™ cleaner provided in the complete PowerPatch™ kit (catalog #EP-KIT). A small piece of the putty stick was cut, mixed, and then applied to the outer portion of the door first. We found that we had to roll the putty into a rope and work around the doors to stop the leak. We left a small area on top for the last bit of putty to seal the door seam entirely. Next, PowerPatch™ was applied over the putty and to the door seam to complete the repair. The bolts were sealed in the same fashion. This repair required many EP-KITs in order to fix all the leaks that were present on this transformer.

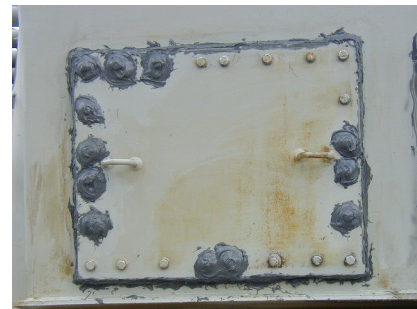
Finished repair of door.

Results: The areas that were sealed with PowerPatch™ are still holding today after a full year of temperature extremes. The transformer now has new leaks in other areas that were not repaired by PowerPatch™.
