## **PowerPatch<sup>™</sup> Current Transformer Repair PSE&G**

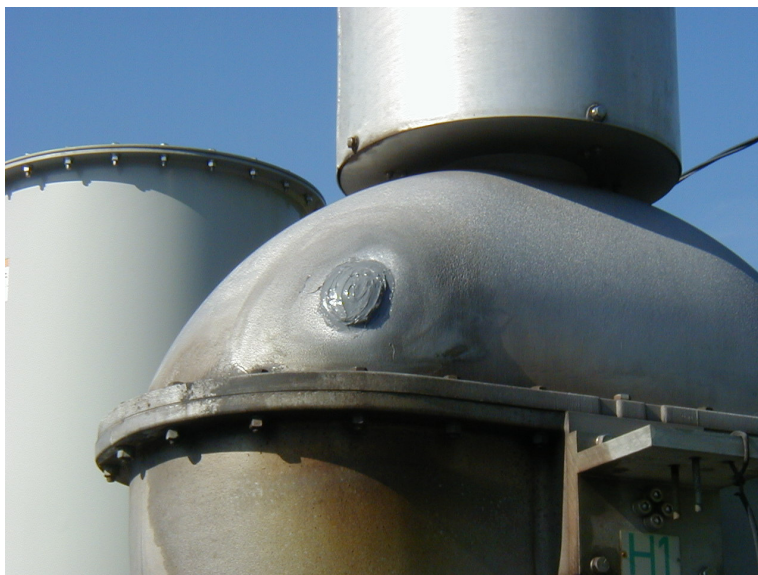
**Problem:** PSE&G had a brand new Current Transformer cast aluminum tank leaking oil from its midsection at a substation. PSE&G's options were to either send the tank back to the manufacturer or to take the tank out of service and repair it themselves by welding.

**Solution:** PSE&G decided to try [PowerPatch<sup>™</sup>](#) to repair the leak instead of taking the equipment out of service. The tank was prepared per PowerPatch<sup>™</sup> instructions. The leak area on the tank was sanded to remove the paint around the leak. To remove the oil, the sanded area was then wiped clean with the [Type TR<sup>™</sup>](#) cleaner provided in the complete PowerPatch<sup>™</sup> kit (catalog #EP-KIT). A small piece of the putty stick was cut, mixed, and then applied to plug the hole. Pressure was applied to the putty until it cured approximately 6 minutes later. Pressure is needed in order to keep the oil from flowing out of the pin-hole leak. Next, parts A & B of PowerPatch<sup>™</sup> were mixed together and then smoothed over the putty stick to make a long-term seal. Within 30 minutes the entire job was completed. To make the PowerPatch<sup>™</sup> last longer in the field it is recommended that you paint over the patch to provide further UV protection.

**Results:** After PowerPatch<sup>™</sup> was applied, the leak stopped. PowerPatch<sup>™</sup> was approved immediately by PSE&G because of its ease of use and economic benefits. PowerPatch<sup>™</sup> was applied in June of 2003 and is still holding today.
